3.0 COAL MINING--Continued  
3.2 Hydrologic Impacts Due To Mine  
Dewatering

EXHIBIT 12

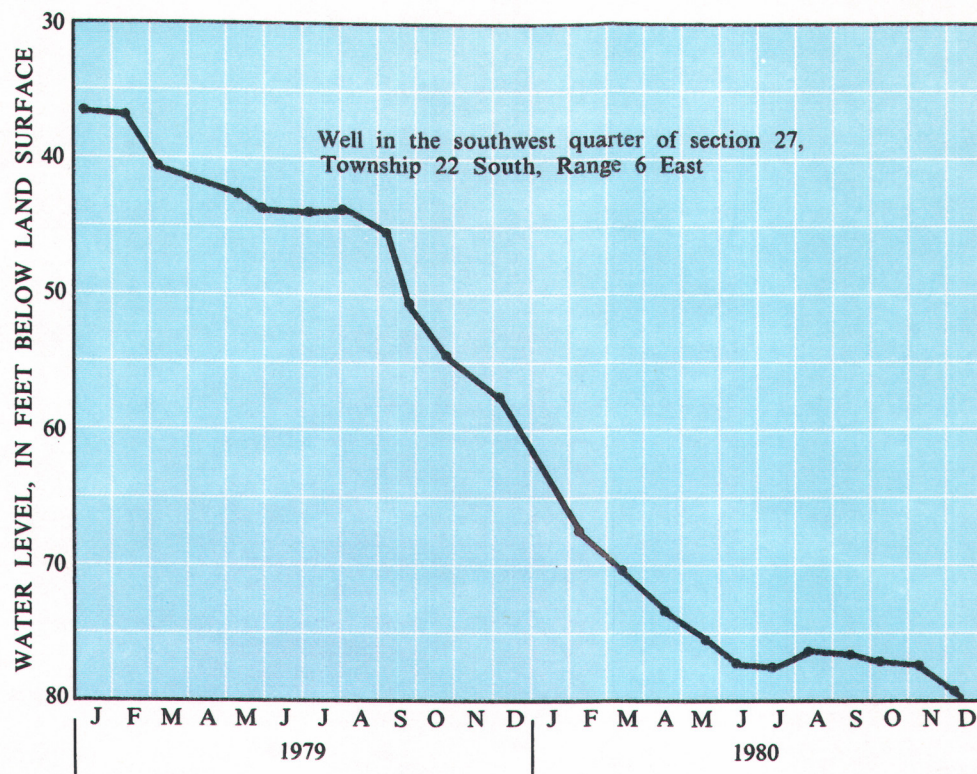
Figure 3.2-3 Water level in a well showing effects of dewatering the Emery Mine. Water levels during 1980 provided by Consolidation Coal Co.

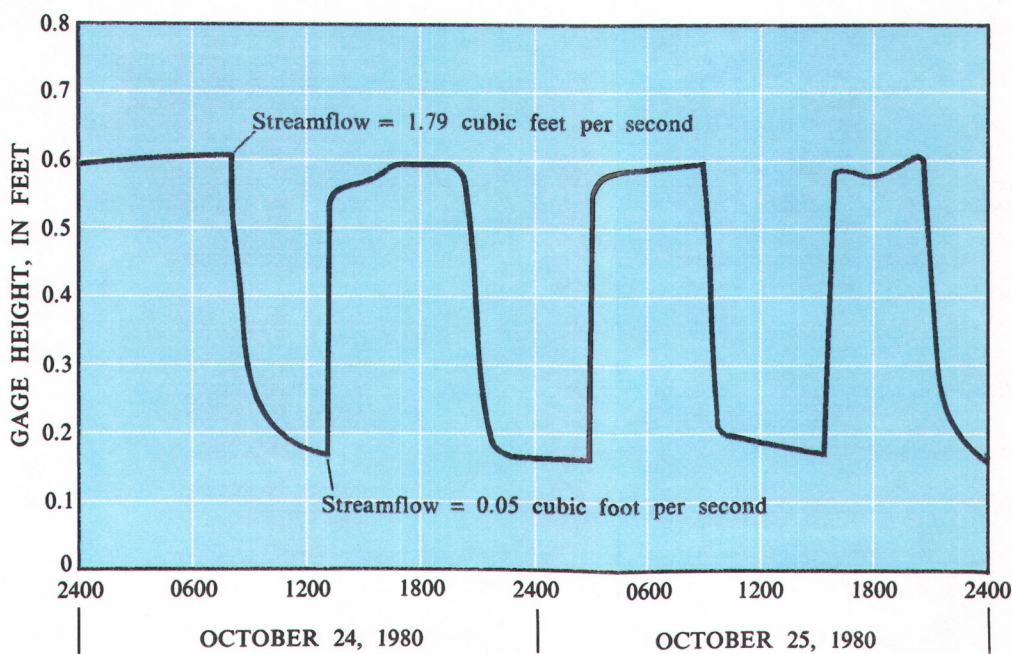
Figure 3.2-4 Effects of periodic discharge of water from the SUFCo Mine on streamflow in Convulsion Canyon at gaging station 09331850 (site 98 in section 10.0).
